Prosthetic Engineering: “Le Pont des Etudiants” in Constantine

Marco Petrangeli & Paolo Tortolini

This paper illustrates the prosthetic reconstruction of a historic masonry viaduct in Algeria. Two of the viaduct arches on the left bank that collapsed because of soil instability have been replaced with a stayed girder that allows for future soil kinematics while restoring the compression in the remaining masonry arches on the right bank. The numerical simulations of the viaduct wreckage needed to assess the integrity of the standing portion and the main issues in the subsequent design and construction of this pioneering intervention are discussed.

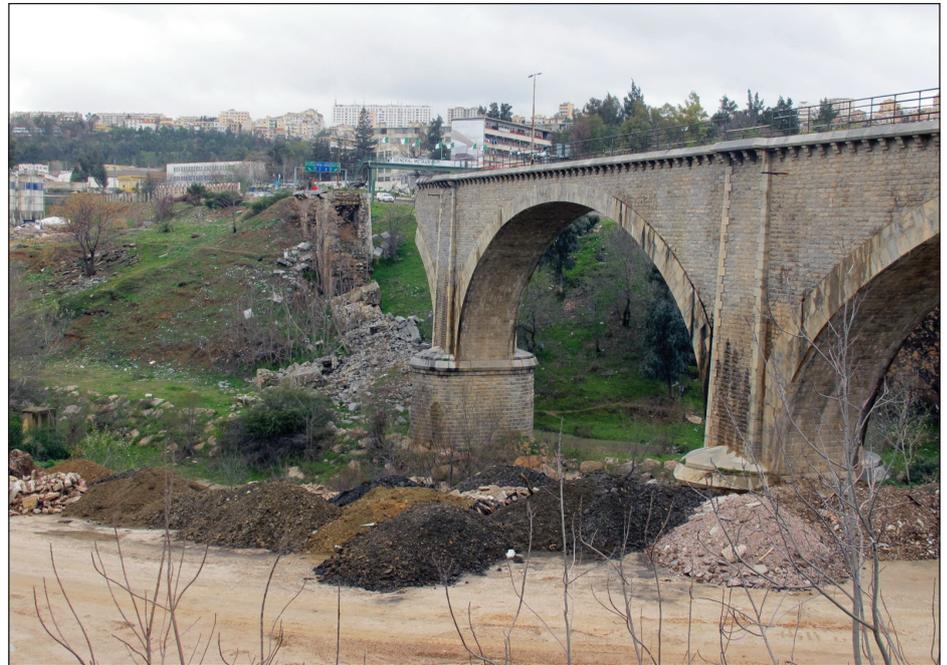
Fig. 1: The Student Bridge in 2014

The “Student Bridge” (Fig. 1) in Constantine is a beautiful stone masonry viaduct built across the Rhumel River few hundred metres downhill from the Constantine University. The bridge, built during the French colonial period for the railway line connecting Constantine to Guelma, became a favourite pedestrian crossing when the railway line was dismissed. In 2004, due to soil instability of the left bank, the first two arches collapsed. The remaining three arches were left there as a remainder of the damage caused by rapid and unsustainable industrialization. Constantine, in the meanwhile, was becoming a city devoured by traffic and sprawling urbanization with resurfacing soil instabilities that, although congenital to the city subsoil, have been greatly enhanced by the lack of a proper land and water management. It happens that the bridge is also on the way to the airport and therefore the first author routinely cast his eyes on the structure in the numerous trips to Constantine, also known as “la ville des ponts,” where other historical bridges have also been in need of repair and strengthening.^{1,2} In 2013, after few enquires and meetings with the local authorities, it was

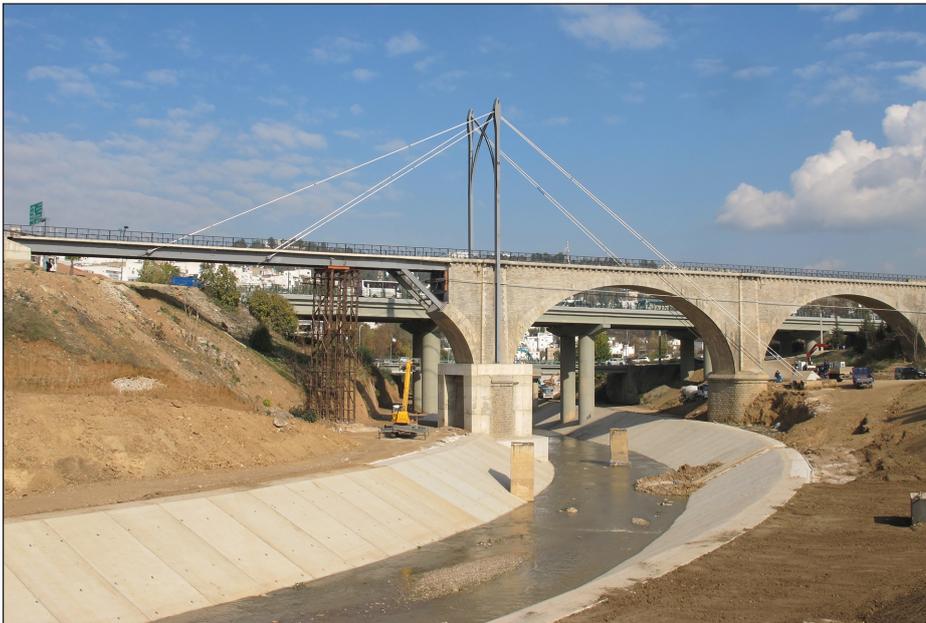
Fig. 6: The repaired bridge

The steel beams and concrete deck were built using two temporary supports over the 50 m span. No much surprise there as the works could be carried out with an easy access and the possibility to amend the final details of the interface between the stayed steel beams and masonry portion after cleaning and removal of debris. Very interesting is the erection of the stays as the stayed structures can have the characteristics varying from very stiff to extremely flexible. The former are better erected with a force-based approach, similar to the post-tensioned ones, and the latter are better tensioned following a displacement controlled procedure (Fig. 6).

schedule. An initial tie back of the mast was imposed by tensioning the back stays (from the anchorage blocks) followed by a subsequent tensioning of the stayed girder. An intermediate control of reactions and stiffness was carried out lifting the deck at the abutment before a final tie back from the anchorages lifted the deck in place.
